**Pressure testing of the airtightness of buildings and sound level measurement with respect to the surroundings – sub-project under Technology procurement for heat recovery systems in existing apartment blocks.**

Bengt Bergqvist of Energianalys has carried out air permeability tests and sound measurements in apartment blocks for Åsa Wahlström of CIT Energy Management.

The air permeability tests were performed in accordance with Swedish Standard SS-EN 13829 during March and April 2010 in a total of 16 apartments in nine apartment blocks.

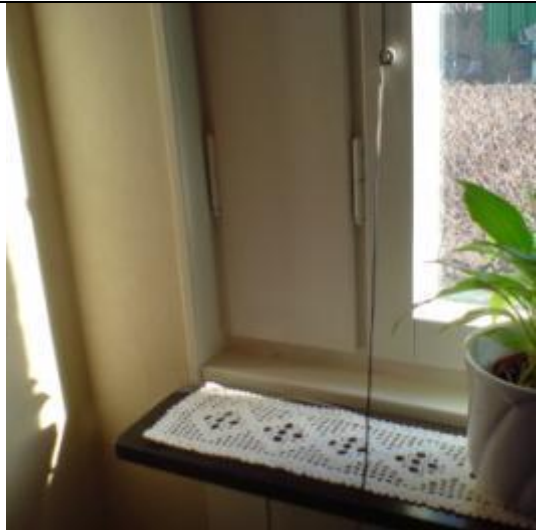
Figure 4a. Kitchen.

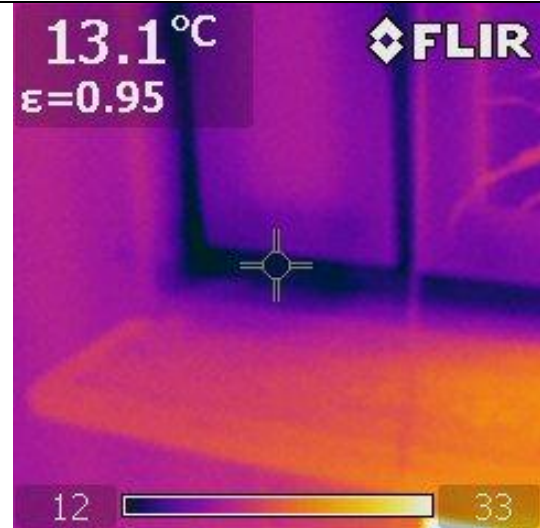
Figure 4b. Leakage between window frame and arch.

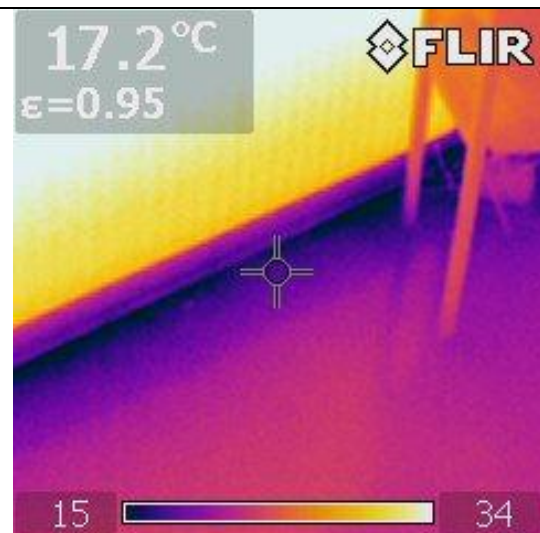
Figure 5b. Leakages between skirting-board and floor.

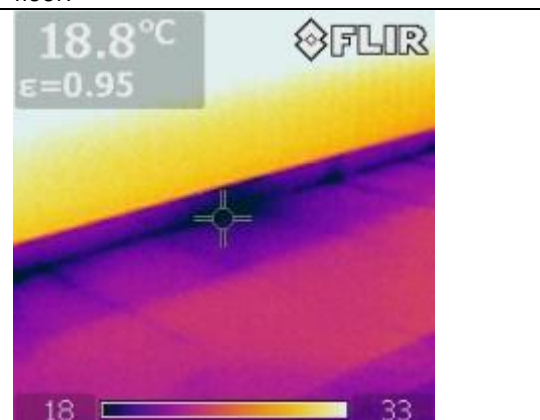
Figure 6b. Leak through external wall between skirting-board and floor.

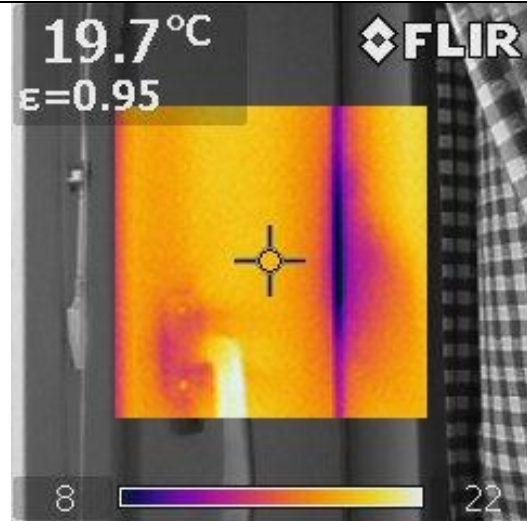
Figure 7b. Leakage between window frame and arch.

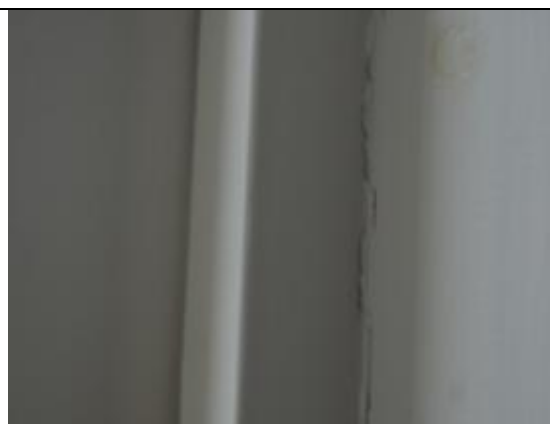
Figure 9a. Living room. Crack between window frame and external wall.

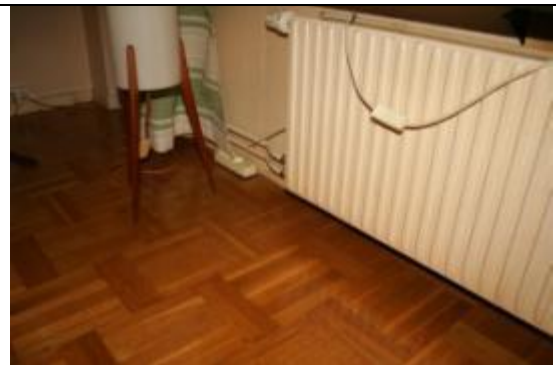
Figure 2b. Living room. Leakage was registered through splice between external wall and floor.

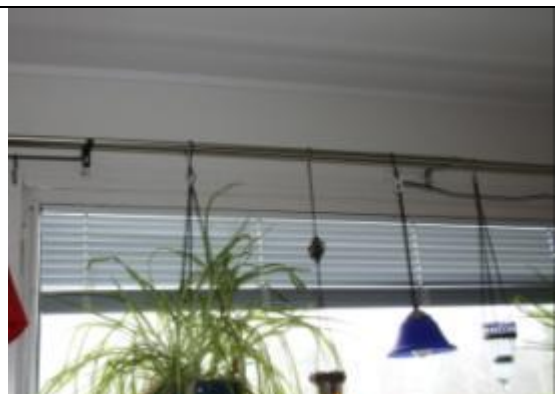
Figure 3a. Living room.

Figure 3b. Leak between window frame and external wall.

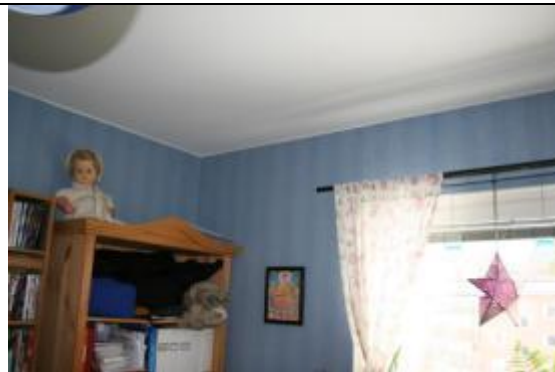
Figure 4a. Bed room.

Figure 4b. Leak through external wall, in ceiling angle.

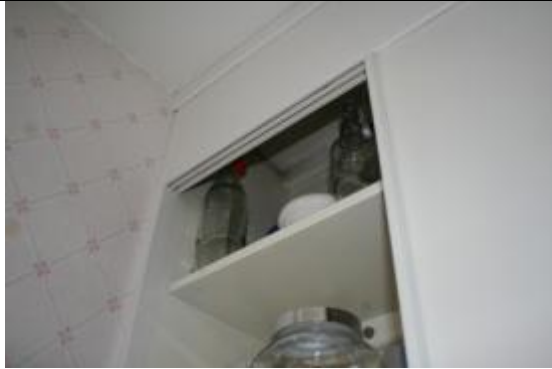
Figure 5a. Kitchen, kitchen cupboard.

Figure 5b. Leak through external wall in ceiling angel inside kitchen cupboard.

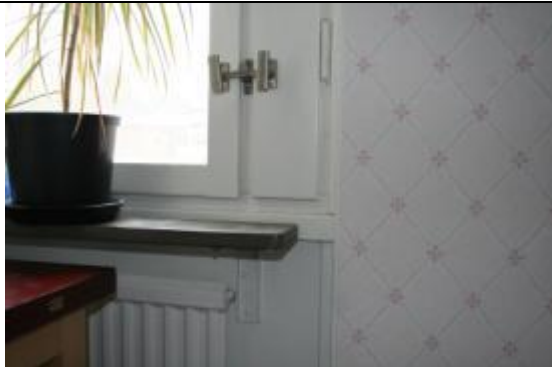
Figure 6a. Kitchen, airing window.

Figure 6b. Leak between window frame and arch.

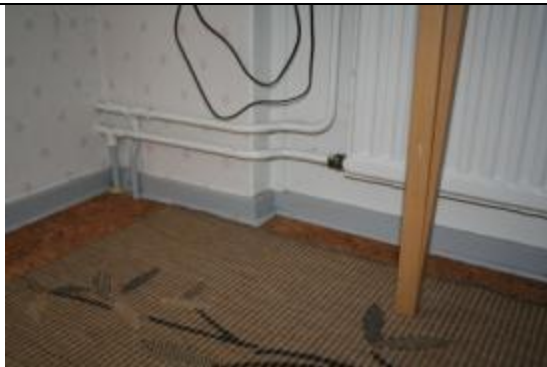
Figure 8a. Kitchen.

Figure 8b. Leak through external wall, at skirting-board.

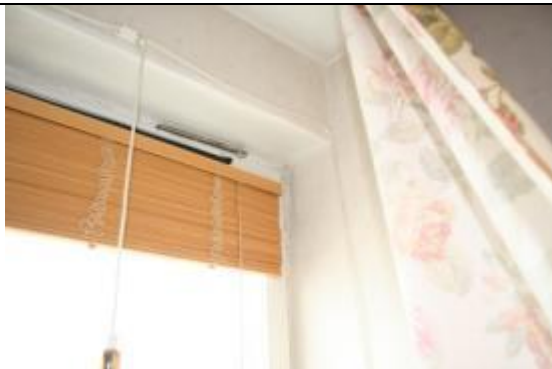
Figure 3a. Bed room, leak trough window frame and arch.

Figure 3b. Bed room, leak trough window frame and arch.

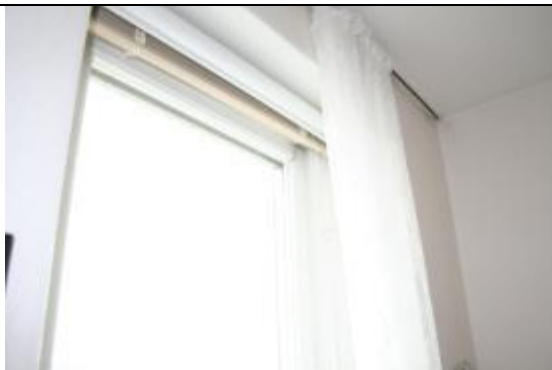
Figure 4a. Leak trough window frame and arch.

Figure 4b. Leak trough window frame and arch.

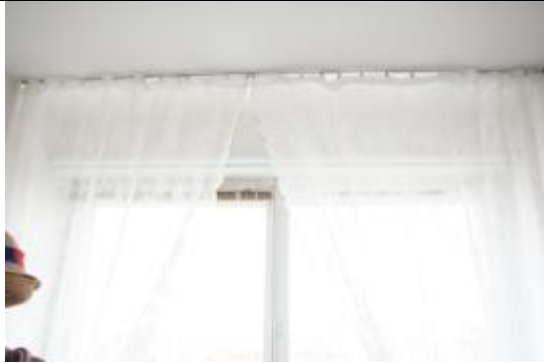
Figure 5a. Bed room, leak trough window frame and arch.

Figure 5b. Bed room, leak trough window frame and arch.

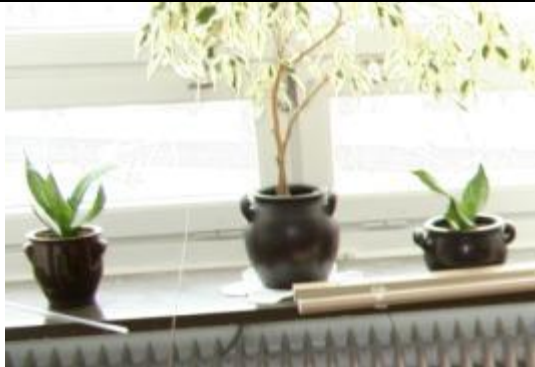
Figure 6a. Bed room, leak trough window frame and arch.

Figure 6b. Bed room, leak trough window frame and arch.

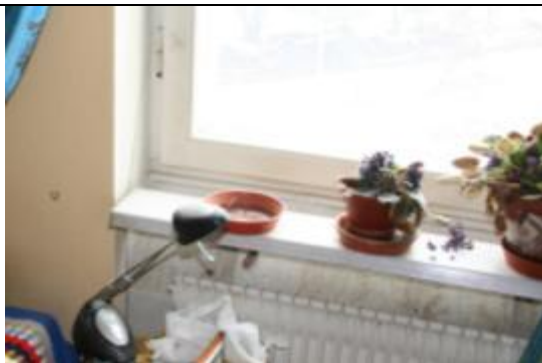
Figure 3a. Bed room, leak trough window frame and arch.

Figure 3b. Bed room, leak trough window frame and arch.

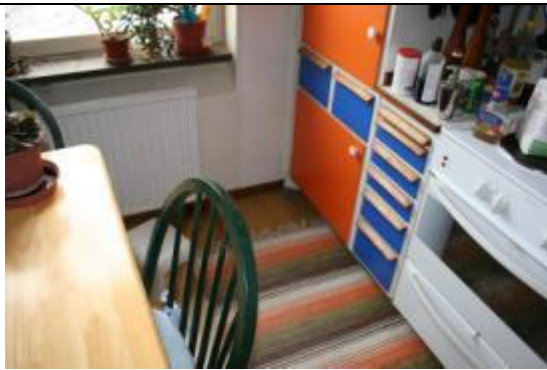
Figure 4a. Kitchen, leak between skirting-board and floor.

Figure 4b. Kitchen, leak between skirting-board and floor.

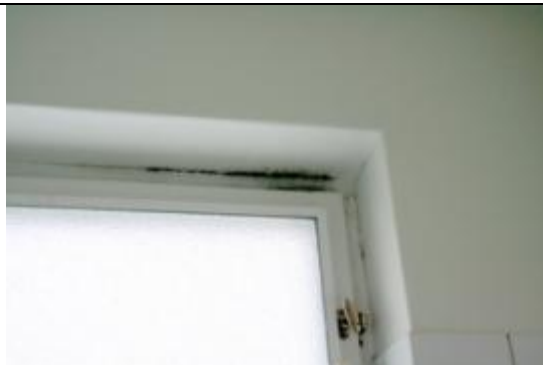
Figure 2a. Bed room, leak trough window frame and arch.

Figure 2b. Bed room, leak trough window frame and arch.

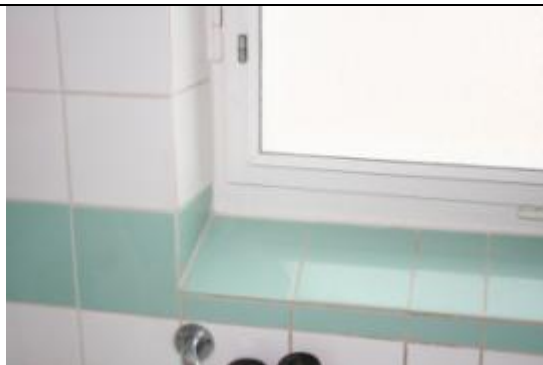
Figure 3a. Bath room, leak trough window frame and arch.

Figure 3b. Bath room, leak trough window frame and arch.

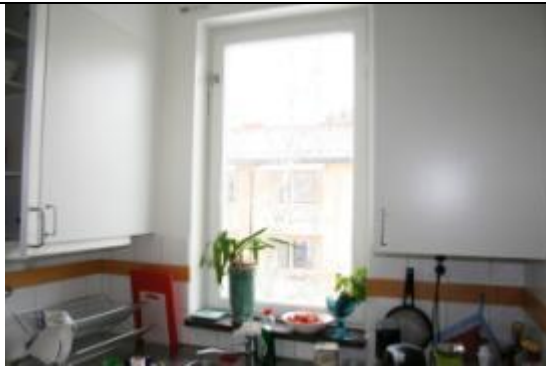
Figure 4a. Kitchen, leak trough window frame and arch.

Figure 4b. Kitchen, leak trough window frame and arch.

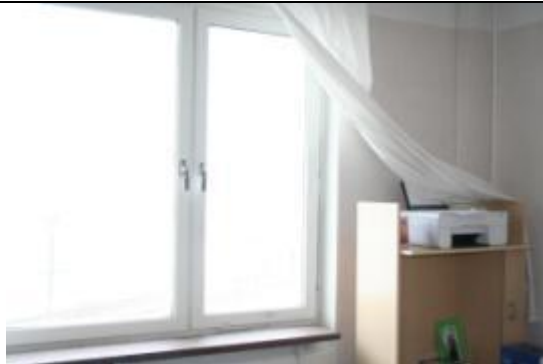
Figure 2a. Leak between windowframe and arch.

Figure 2b. Leak between windowframe and arch.

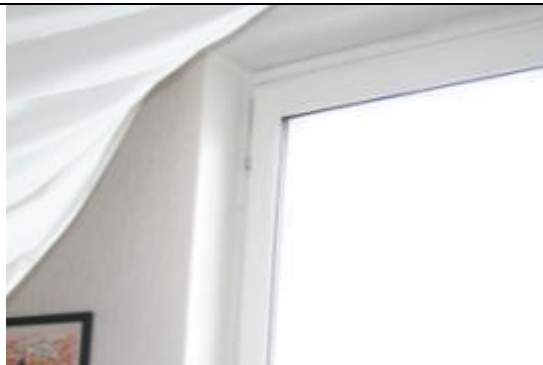
Figure 3a. Leak between windowframe and exterior wall.

Figure 3b. Leak between windowframe and exterior wall.

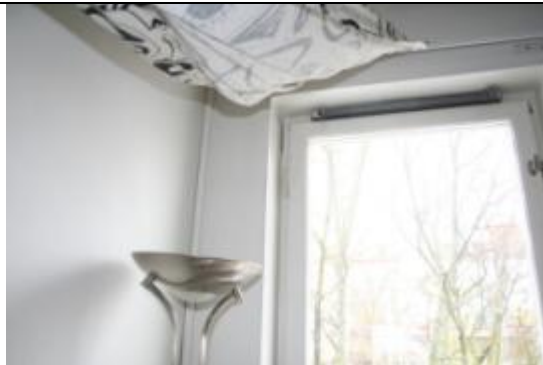
Figure 4a. Leak between window frame and arch.

Figure 4b. Leak between window frame and arch.

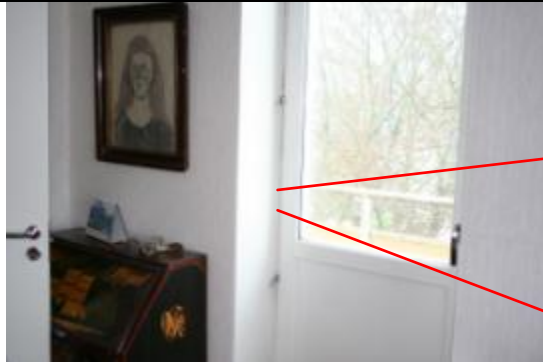
Figure 6a. Balcony door.

Figure 6b. Leak through crack in door frame.

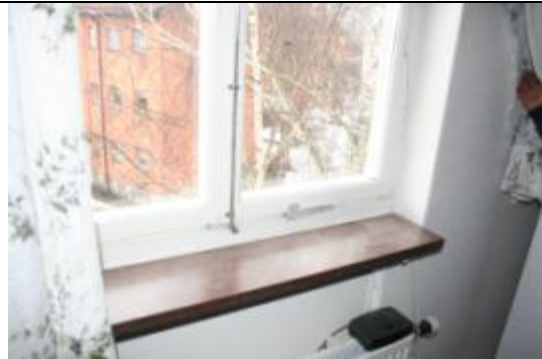
Figure 2a. Leak trough window frame and arch.

Figure 2b. Leak trough window frame and arch.

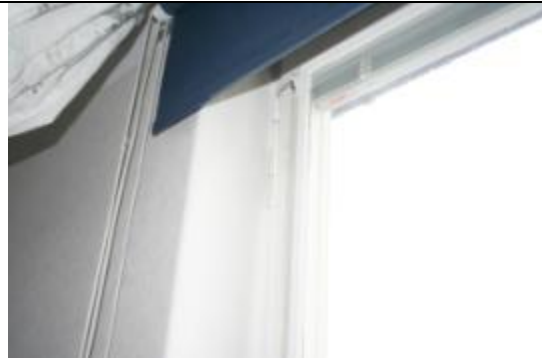
Figure 3a. Läckage vid genomföring för persiennstyrning.

Figure 3b. Läckage vid genomföring för persiennstyrning.

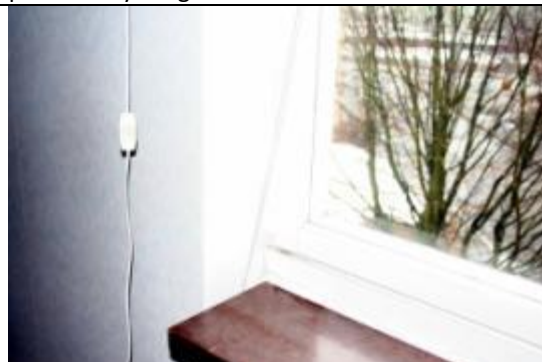
Figure 4a. Leak trough window frame and arch.

Figure 4b. Leak trough window frame and arch.

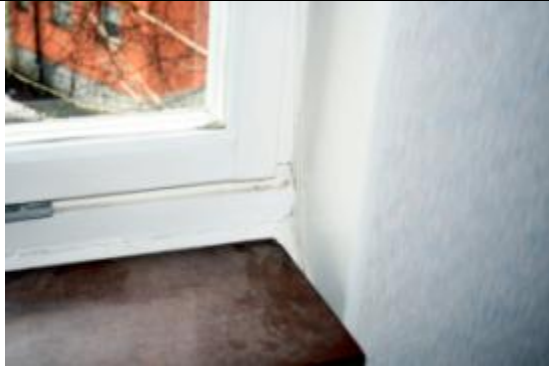
Figure 5a. Leak through window frame.

Figure 5b. Leak through window frame.

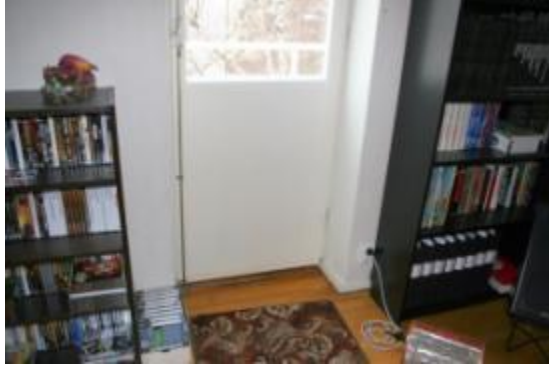
Figure 6a. Balcony door, living room

Figure 6b. Leak between skirting-board and floor.

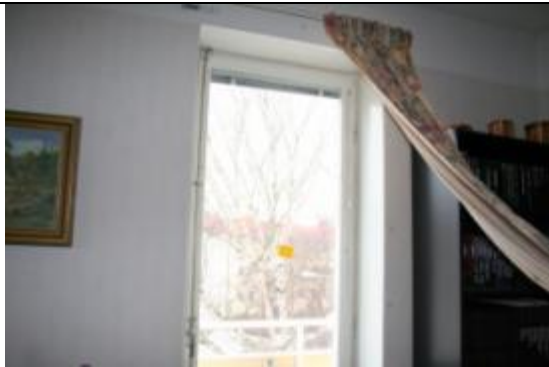
Figure 7a. Balcony door, living room

Figure 7b. Leak between door frame and arch.

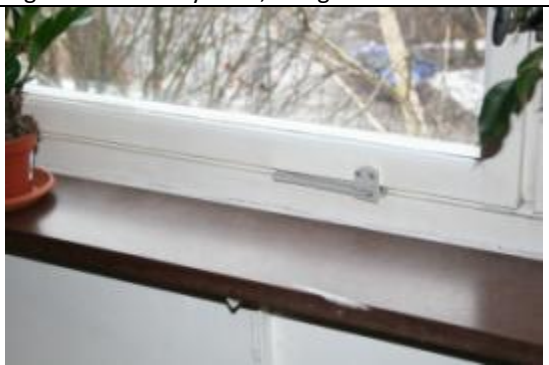
Figure 8a. Leak trough crack in window frame.

Figure 8b. Leak trough crack in window frame.

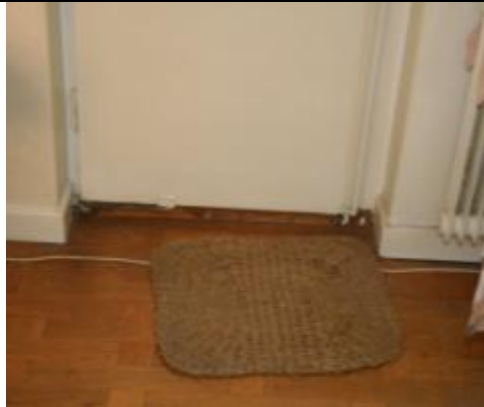
Figure 2a. Leak at balcony door.

Figure 2b. Leak at balcony door.

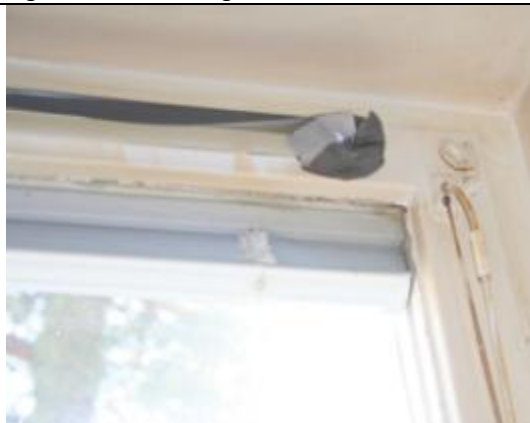
Figure 4a. Leak trough window glas and arch and between frame and arch.

Figure 4b. Leak trough window glas and arch and between frame and arch.

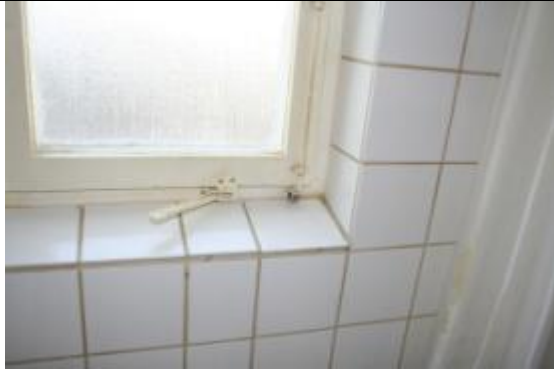
Figure 5a. Leak trough window frame and arch.

Figure 5b. Leak trough window frame and arch.

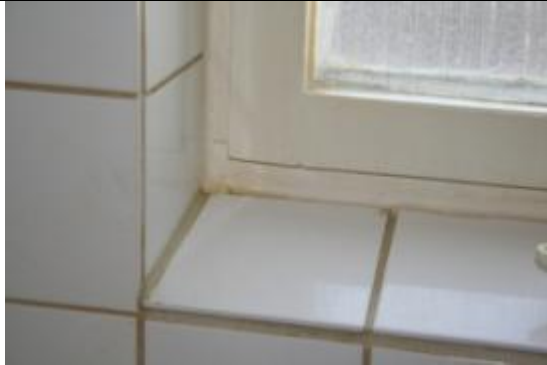
Figure 6a. Leak trough window frame and arch.

Figure 6b. Leak trough window frame and arch.

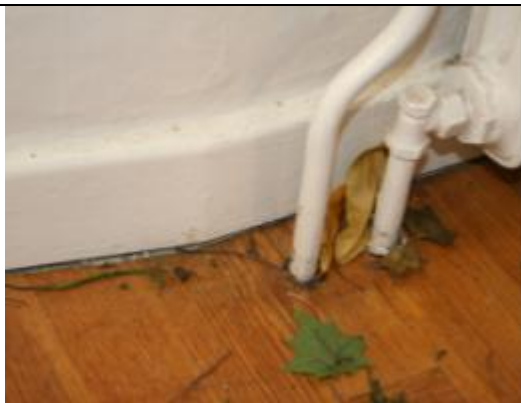
Figure 4a. Leak between skirting-board and floor.

Figure 4b. Leak between skirting-board and floor.

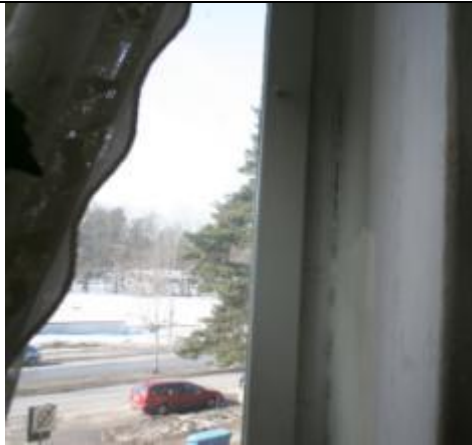
Figure 5a. Leak trough window frame and arch.

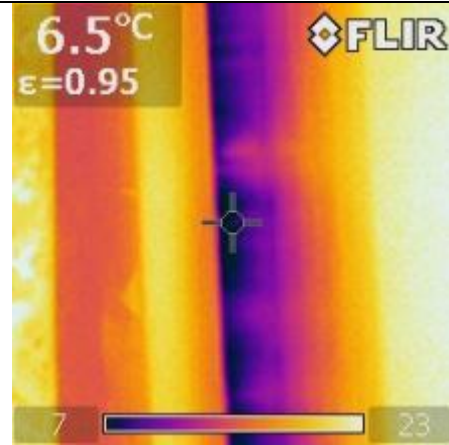
Figure 5b. Leak trough window frame and arch.

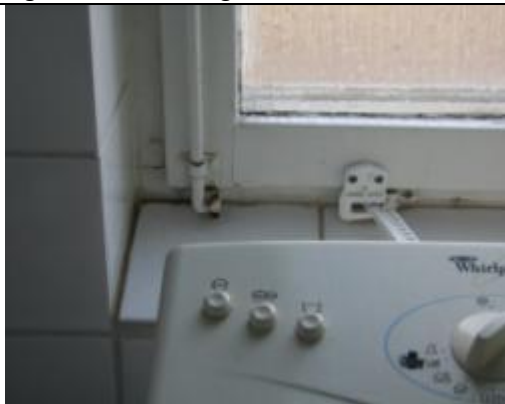
Figure 7a. Leak trough window frame and arch.

Figure 7b. Leak trough window frame and arch.

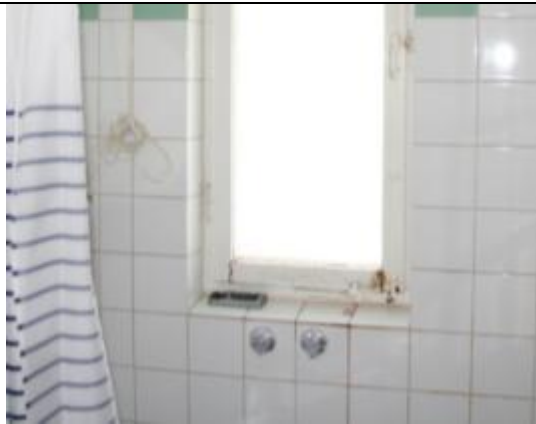
Figure 3a. Bath room, leak trough window frame and arch.

Figure 3b. Bath room, leak trough window frame and arch.

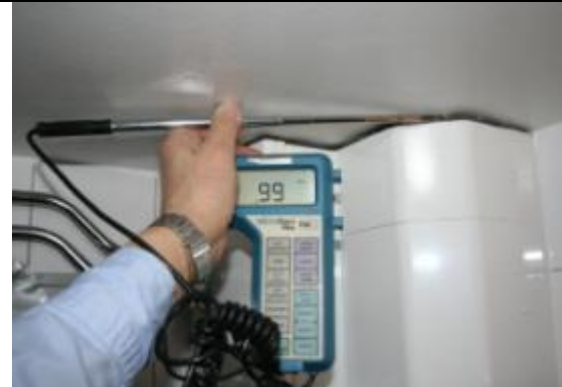
Saltvägen 10, apt 1 and apt 2, Farsta, have a leaky shaft as a result of the replacement of main services. There have been complaints about problems with the spread of tobacco smoke between apartments, for example.

Figure 10a. The biggest leak was found at mounting for water pipes. Probably is fire tightening between pipe and structure untight and air may be overflow between apartments. The tenant has problem with smell of smoke from the neighbor.

Figure 10b. In crack to ducts was air speeds measured around 1m/s that probably depend on leaking air from the neighbor. Under pressure in the apartment was constant at -50 Pa during this measurement. (Water pipes were changed in 2005)

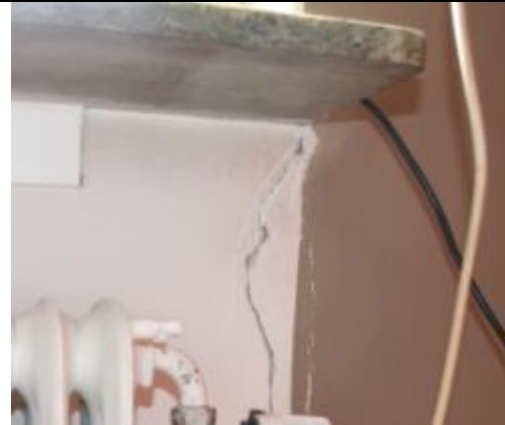
Figure 2a. Leak through crack in exterior wall.

Figure 2b. Leak through crack in exterior wall.

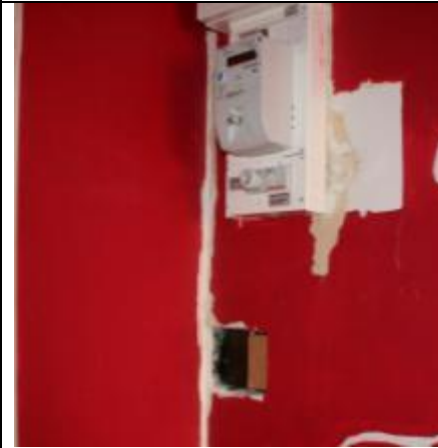
Figure 7b. A smaller air leakage was indicated within the electrical control unit.

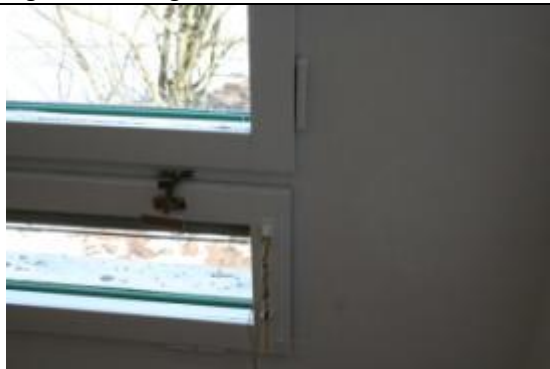
Figure 4a. Living room

Figure 4b. Leak between window frame and arch, and through bushings for venetian blind control.

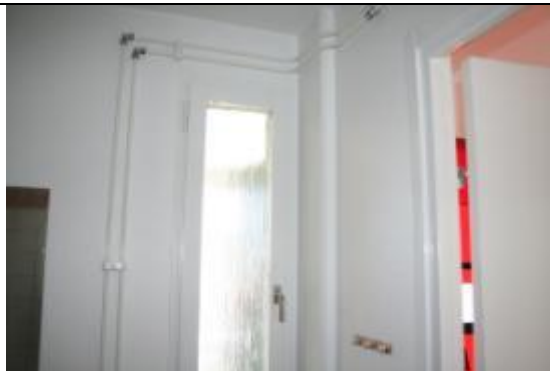
Figure 5a. Bath room

Figure 5b. Leak between window frame and arch.

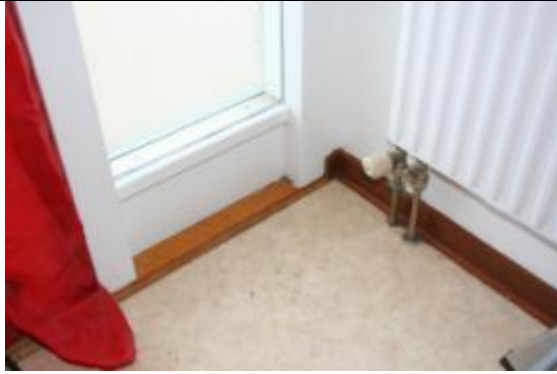
Figure 6a. Hall.

Figure 6b. Leak between window and floor.

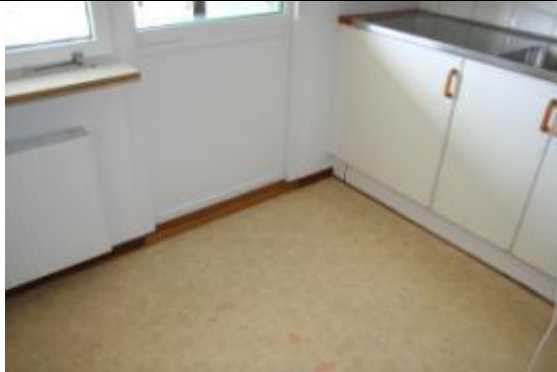
Figure 7a. Kitchen

Figure 7b. Leak between window frame and arch.

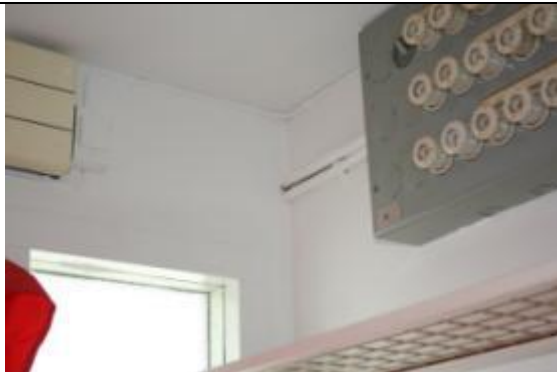
Figure 8a. Hall.

Figure 8b. Leak throgth bushing for electrical cable.

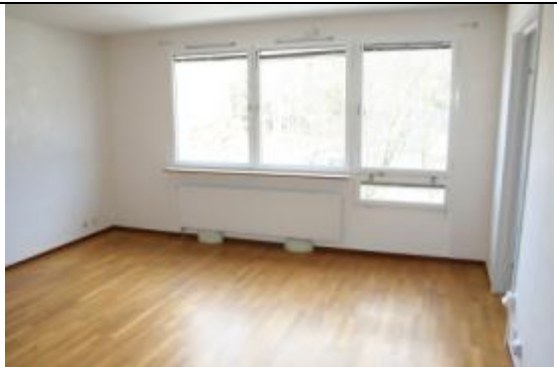
Tallrisvägen 43 and Granrisvägen 1 in Örebro have an old supply air system which is no longer in use but which is connected to other apartments in the building. About 50% of all leakage air is in the form of transfer air from other apartments.

Figure 9a. Original balanced mechanical ventilation with supply air devices ("Elephant foot") in floor have been changed with exhaust air ventilation with exterior air devices (Biobe) in window frame. The old supply air system is not sealed and it is possible for air change between apartments. The measurements showed an air change between apartments of about 33 l/s, ( 9+9+15=33 l/s).

Figure 9b. In bed room was air speeds of 2 m/s measured in supply air opening (air from the other apartment). 2 m/s correspond to about 9 l/s in the opening.

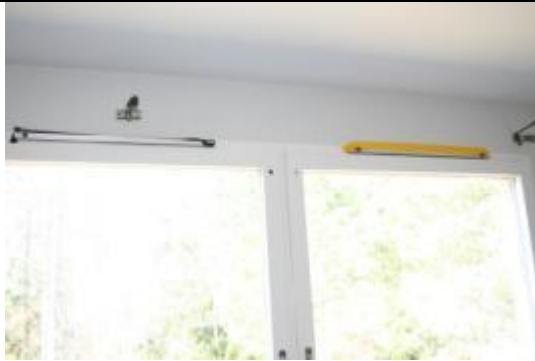
Figure 3a. Living room.

Figure 3b. Leak throgth bushing for control of ventian blinds.
