**Pressure testing of the airtightness of buildings and sound level measurement with respect to the surroundings – sub-project under Technology procurement for heat recovery systems in existing apartment blocks.**

Bengt Bergqvist of Energianalys has carried out air permeability tests and sound measurements in apartment blocks for Åsa Wahlström of CIT Energy Management.

The air permeability tests were performed in accordance with Swedish Standard SS-EN 13829 during March and April 2010 in a total of 16 apartments in nine apartment blocks.

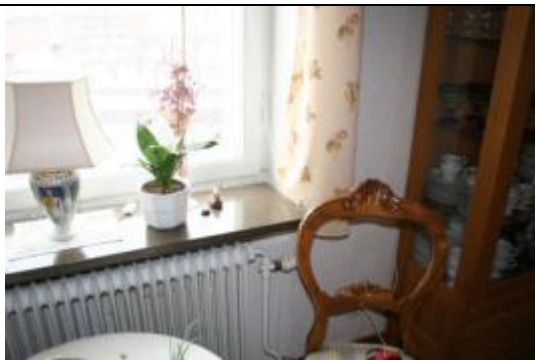
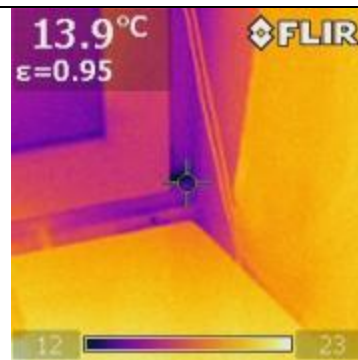
Figure 2a. Living room, leak trough window frame and arch.

Figure 2b. Living room, leak trough window frame and arch.

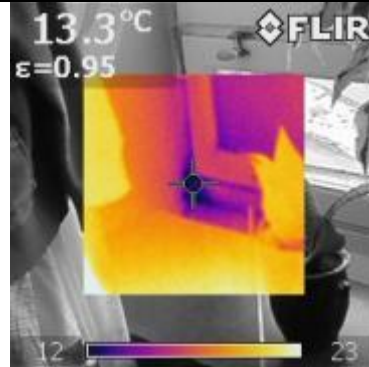
Figure 6b. Bed room, leak trough window frame and arch.

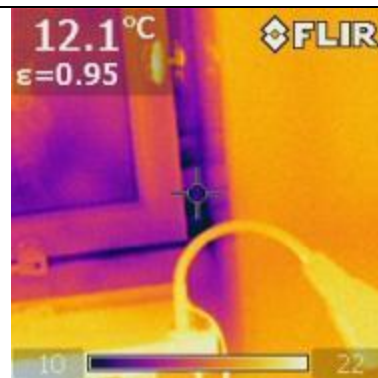
Figure 5. Leak trough window frame and arch.

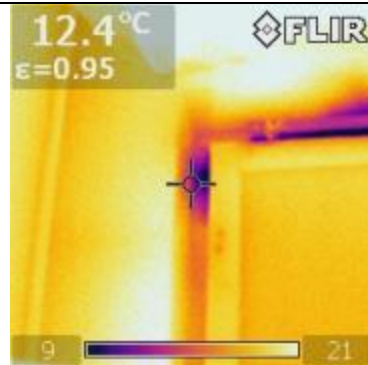
Figure 4b. Leak between window frame and arch.

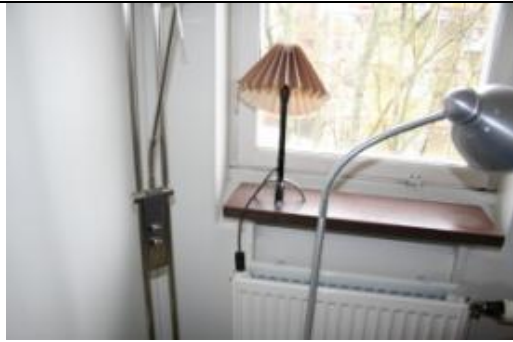
Figure 5a. Leak between windowframe and arch.

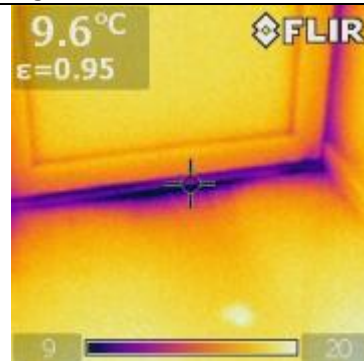
Figure 7b. Balcony door, leak between doorstep and floor.

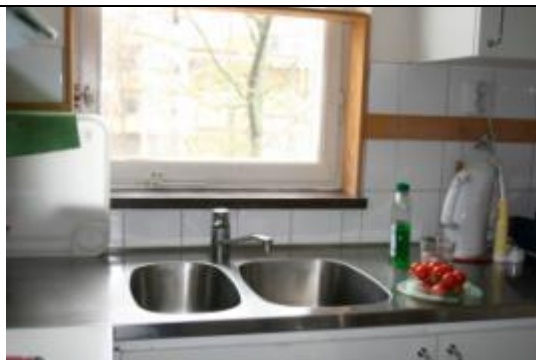
Figure 8a. Kitchen, leak trough window frame and arch.

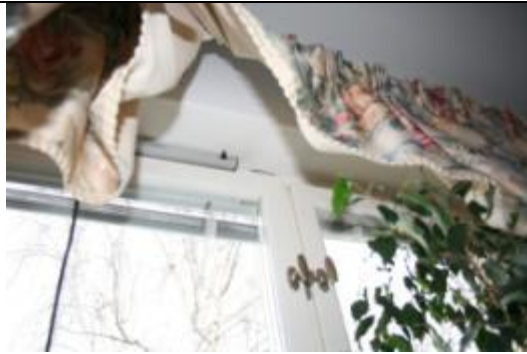
Figure 10a. Leak trough window frame and arch.

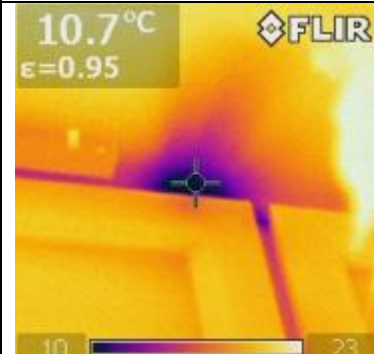
Figure 10b. Leak trough window frame and arch.

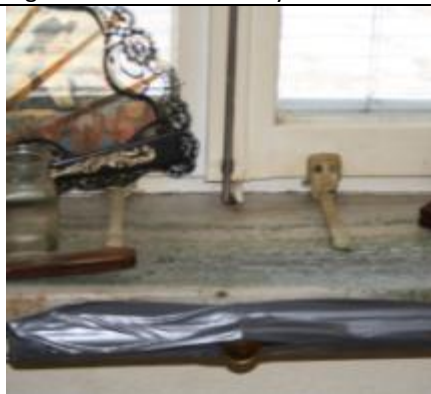
Figure 3a. Leak trough window frame and arch.

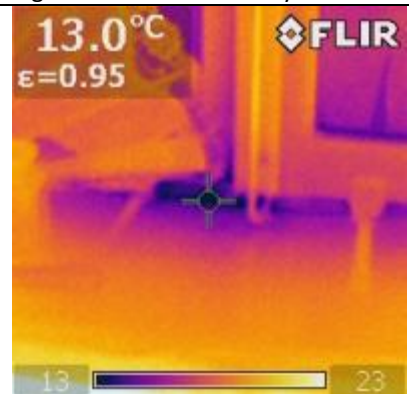
Figure 3a. Leak trough window frame and arch.

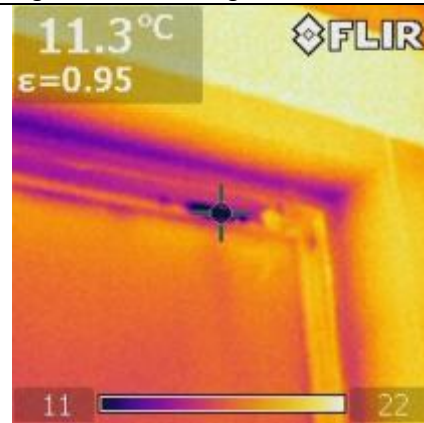
Figure 4b. Leak trough window glas and arch and between frame and arch.

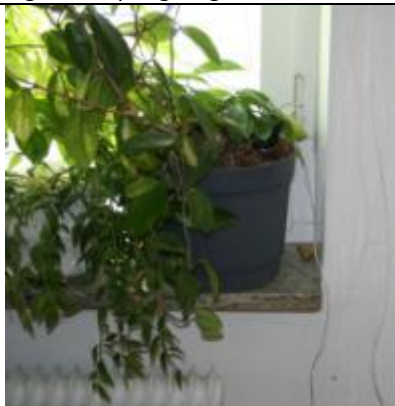
Figure 2a. Leak trough window frame and arch.

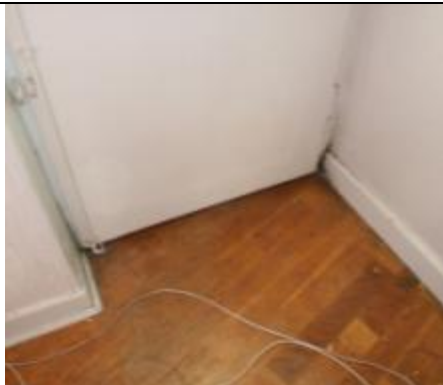
Figure 3a. Leak through balcony door (between arch and frame/ doorstep).

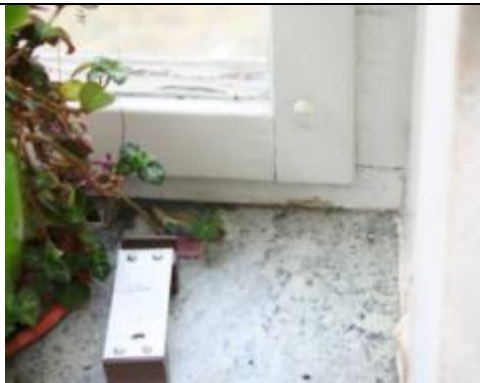
Figure 6a. Leak trough window frame and arch.

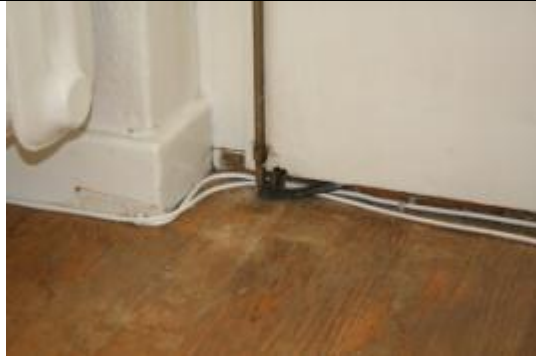
Figure 2a. Leak at balcony door, between arch and door frame/step.

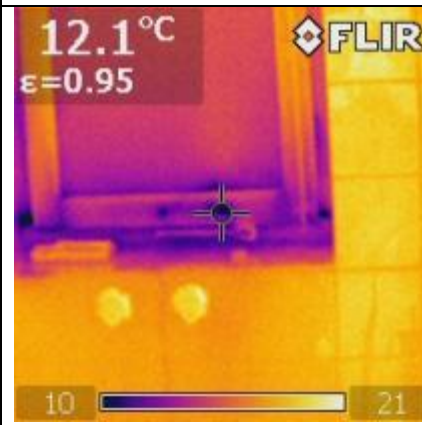
Figure 3b. Bath room, leak trough window frame and arch.

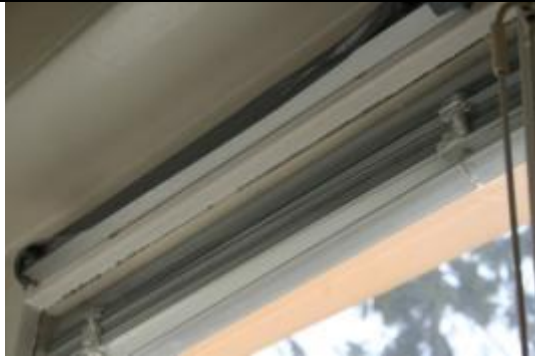
Figure 4a. Leak between external air device and window arch.

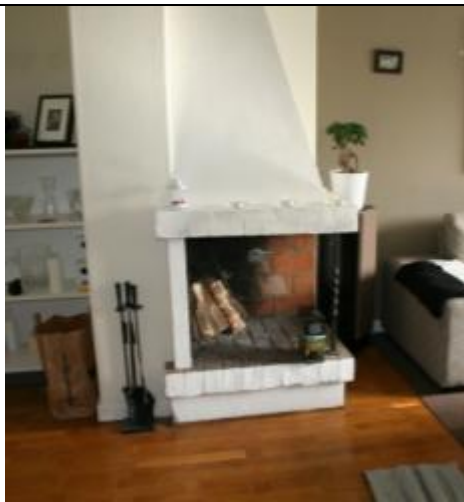
Figure 5a. Air tightness testing were performed both with sealed stove and unsealed stove. The smoke damper was closed in both measurements.

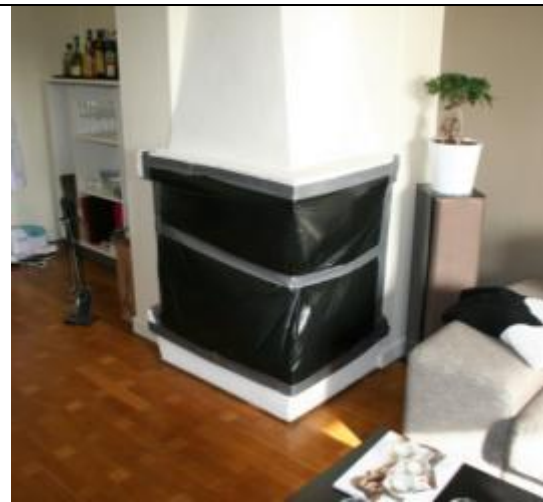
Figure 5b. No measurable difference in air flows were registered between sealed and unsealed stove.

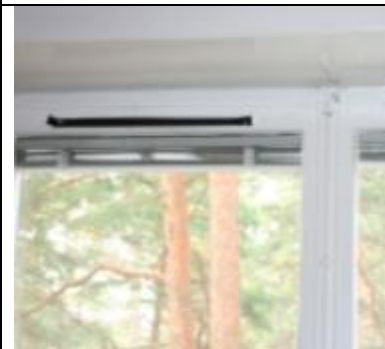
Figure 2b. Leak through crack between external air device and window arch.

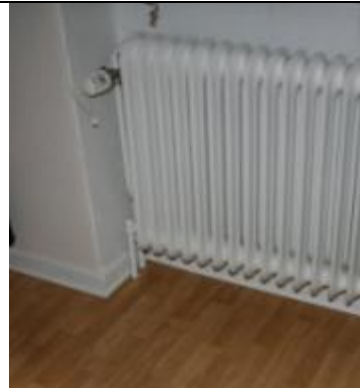
Figure 5b. Bed room, leak between skirting-board and floor.

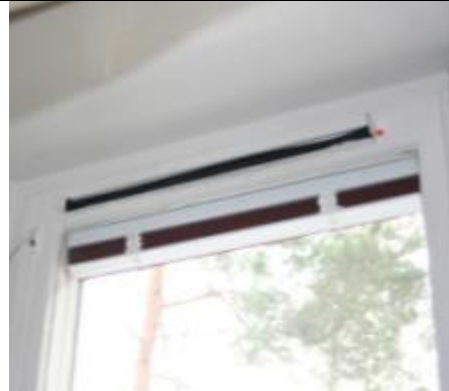
Figure 6b. Leak between external air device and window arch.

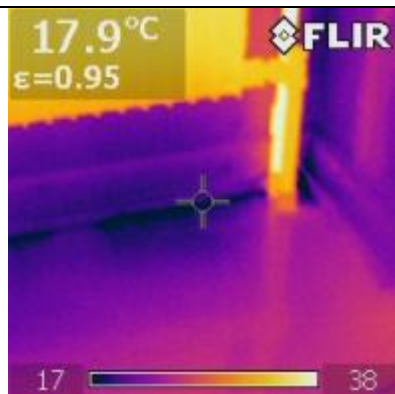
Figure 7a. Leak between skirting-board and floor.

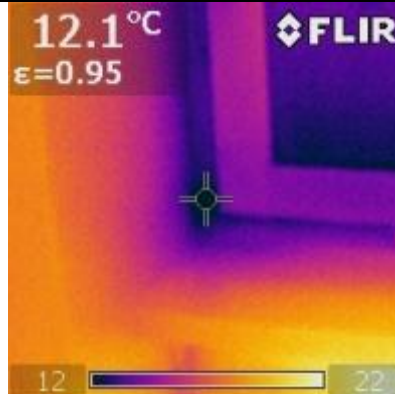
Figure 8a. Leak between window frame and arch.

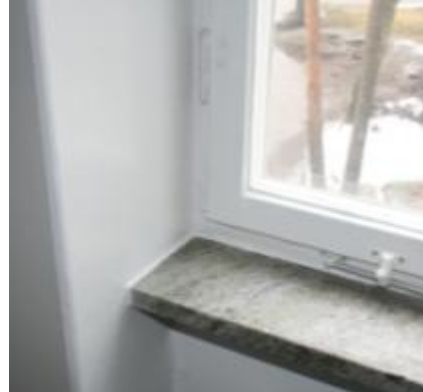
Figure 8b. Leak between window frame and arch.

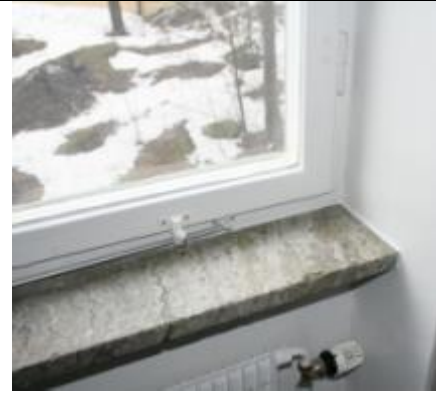
Figure 9b. Leak between window frame and arch.

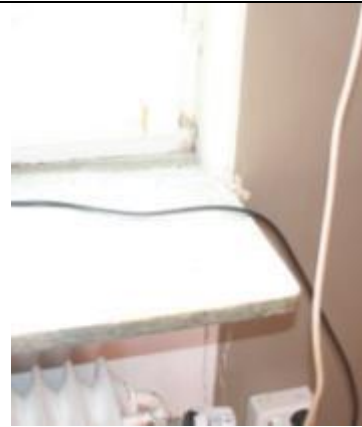
Figure 3b. Leak through window frame and arch.

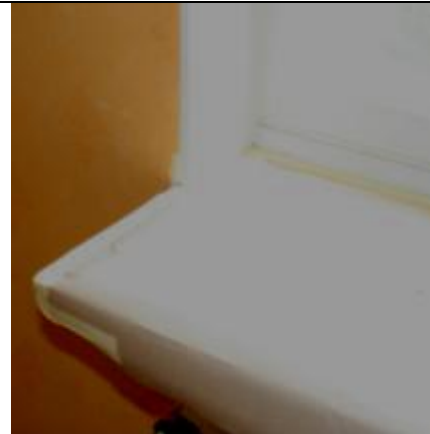
Figure 4b. Leak through window frame and arch.

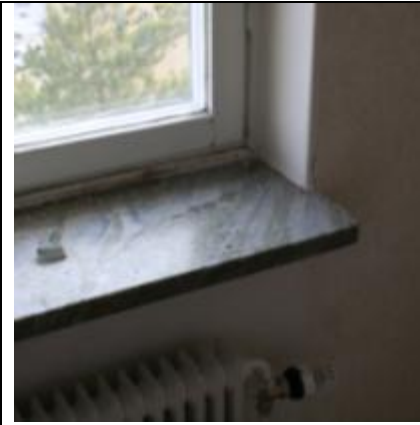
Figure 5b. Leak through window frame and arch.

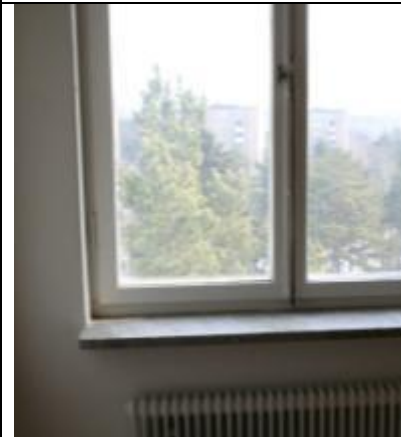
Figure 6b. Leak through window frame and between frame and arch.

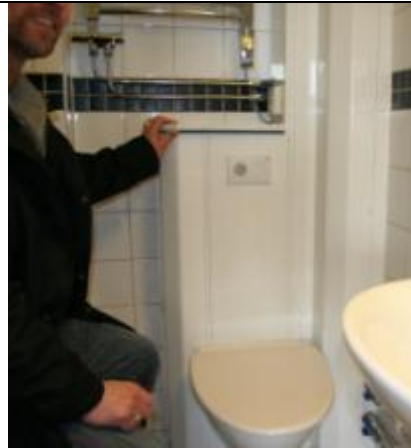
Figure 7a. An air leakage was measured with hot wire anemometer through opening of cover to the WC shaft. 0.3 m/s was indicated.

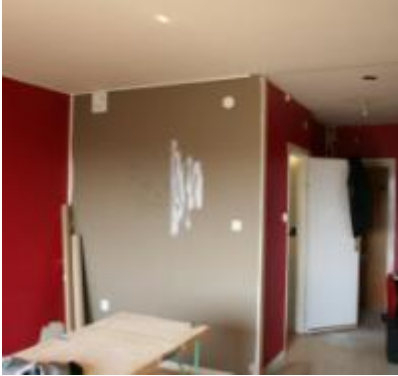
Figure 8a. The apartment has, exhaust air devices both in bath room and living room.

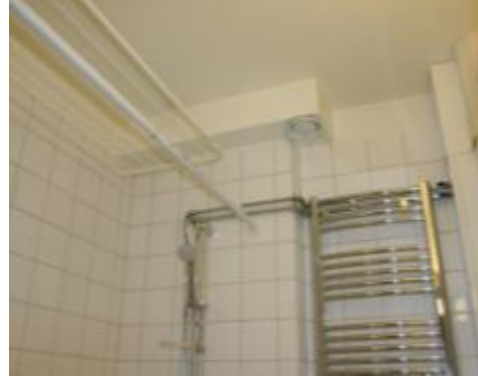
Figure 8b. Exhaust air device in bath room and horizontal duct to exhaust air device in living room.

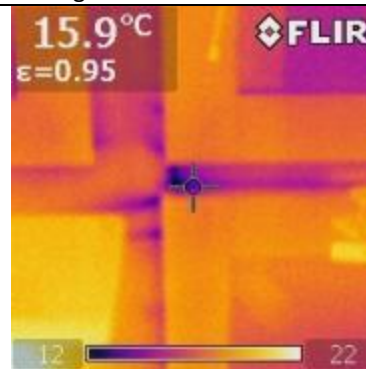
Figure 3a. Living room

Figure 3b. Leak between window frame and arch.

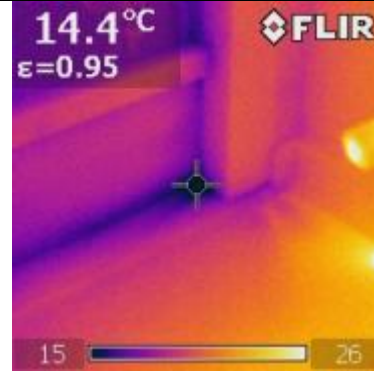
Figure 6a. Hall.

Figure 6b. Leak between window and floor.

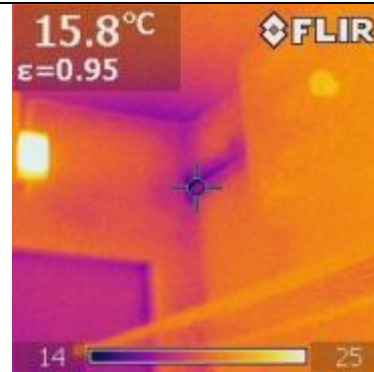
Figure 8a. Hall.

Figure 8b. Leak throgth bushing for electrical cable.

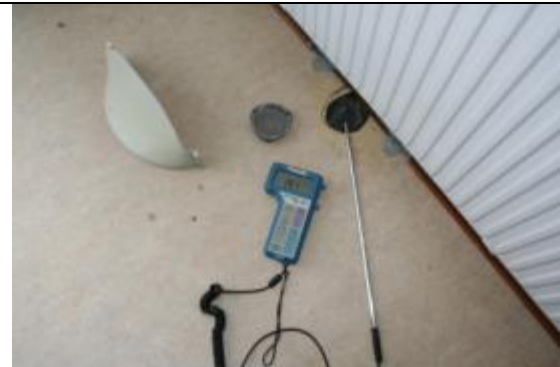
Figure 9a. Original balanced mechanical ventilation with supply air devices ("Elephant foot") in floor have been changed with exhaust air ventilation with exterior air devices (Biobe) in window frame. The old supply air system is not sealed and it is possible for air change between apartments. The measurements showed an air change between apartments of about 33 l/s, ( 9+9+15=33 l/s).

Figure 9b. In bed room was air speeds of 2 m/s measured in supply air opening (air from the other apartment). 2 m/s correspond to about 9 l/s in the opening.

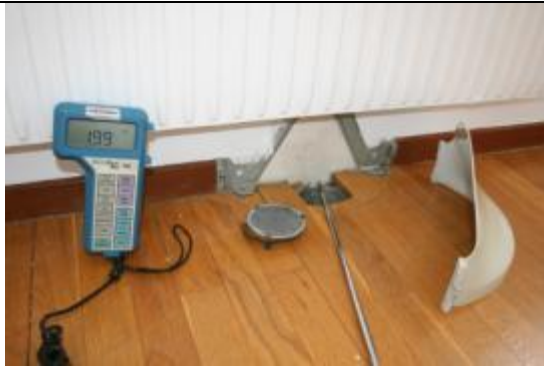
Figure 10a. In living room were 2 m/s measured in the opening, corresponding to about 9 l/s.

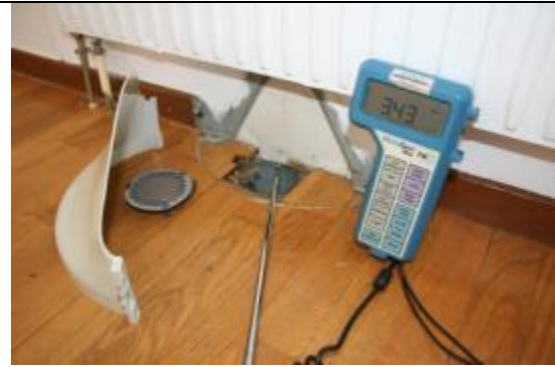
Figure 10b. In the second floor opening in the living room was an air speed of 3,4 m/s measured, corresponding to about 15 l/s.

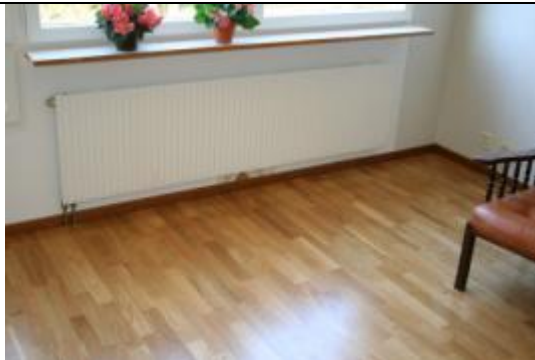
Figure 2a. Living room. Installation of new floor hides two supply air openings from an old supply air system. Now its renovated to anexhhaust air system.

Figure 2b. Leak, probably by air from neighbor apartment through the old supply air sysem under the new floor.

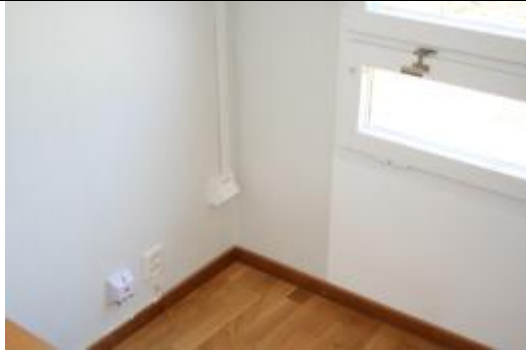
Figure 5a. . Living room, leak in corner between skirting-board and floor.

Figure 5a. . Living room, Leak in corner between skirting-board and floor.

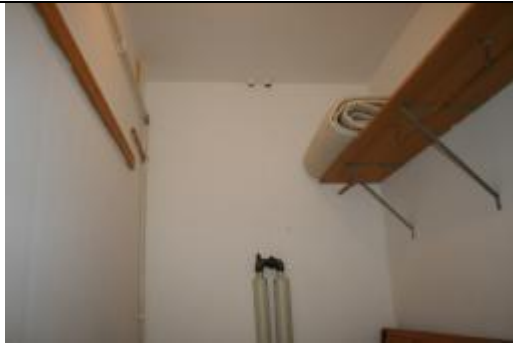
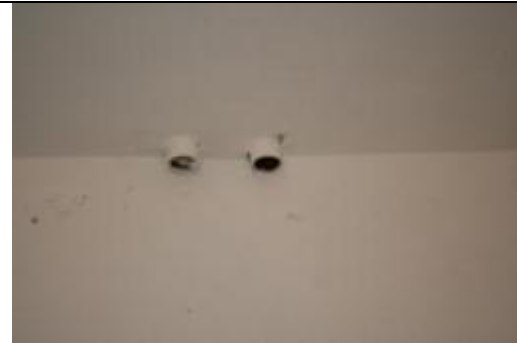
Figure 6a. Two cut offed pipes in the ceiling in cloths cupboard.

Figure 6b. Two cut offed pipes in the ceiling in cloths cupboard.

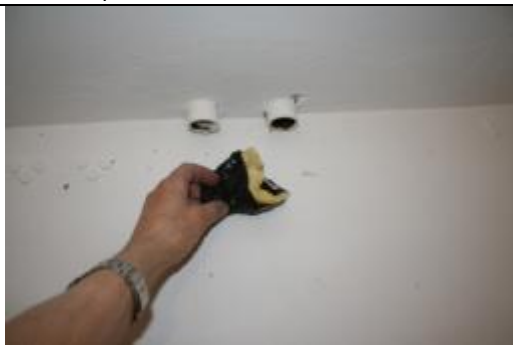
Figure 7a. The pipes were temporarily sealed with glass wool.

Figure 7b. Measurements without glass wool gives relatively high speeds of under tempered air.

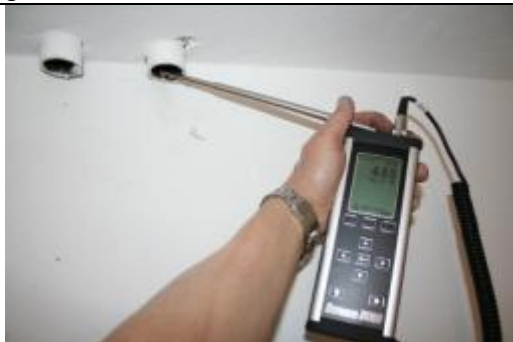
Figure 8a. Air speeds about 5 m/s was measured in pipe opening at an under pressure of 50 Pa. Air temperatures was measured to +14°C, which indicates that it is outdoor air and not air from neighbor apartment.

Figure 8b. Air speeds about 5 m/s was measured in pipe opening at an under pressure of 50 Pa. Air temperatures was measured to +14°C, which indicates that it is outdoor air and not air from neighbor apartment.

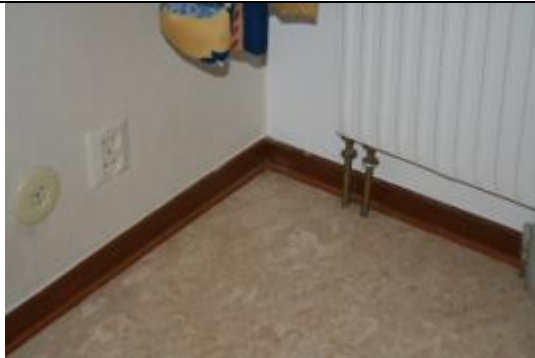
Figure 9a. Bed room, leak in corner between skirting-board and floor.

Figure 9b. Bed room, leak in corner between skirting-board and floor.

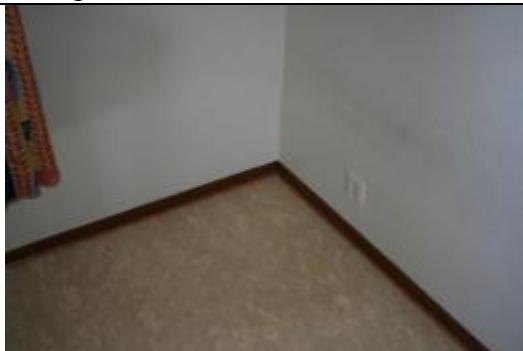
Figure 10a. Bed room, leak in corner between skirting-board and floor.

Figure 10b. Bed room, leak in corner between skirting-board and floor.

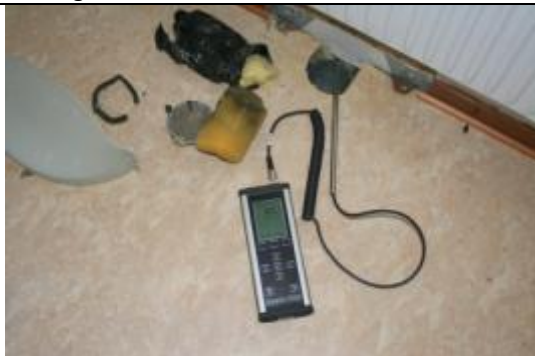
Figure 11a. Supply air device in bed room was temporary sealed with glass wool and foam plastic. Without sealing was an air speed of 4 m/s measured in the opening and an air temperature of +20°C, which indicates that it is air from neighbor apartment.

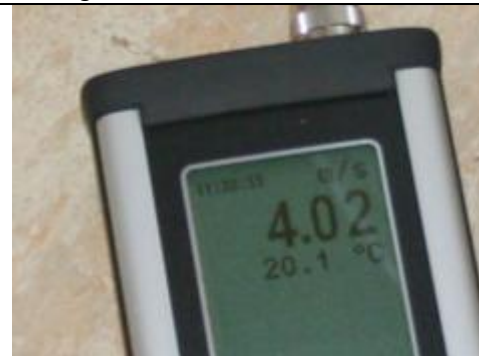
Figure 11a. Supply air device in bed room was temporary sealed with glass wool and foam plastic. Without sealing was an air speed of 4 m/s measured in the opening and an air temperature of +20°C, which indicates that it is air from neighbor apartment.

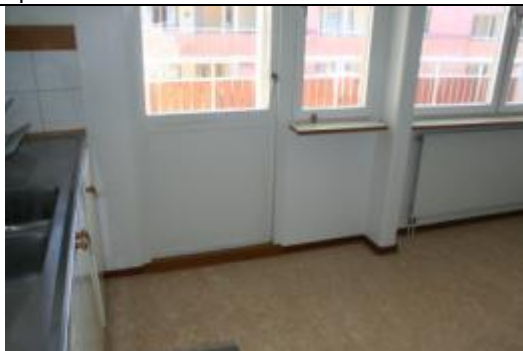
Figure 12a. Kitchen. Large leak between balcony door and door frame.

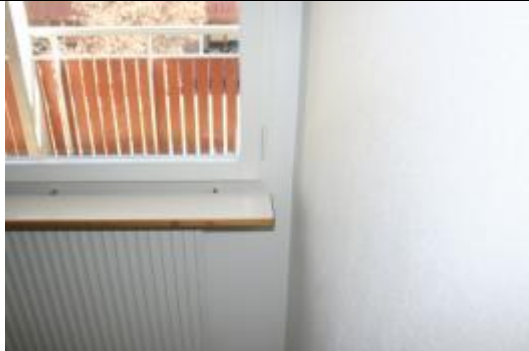
Figure 14a. Kitchen. Leak between window frame and arch.

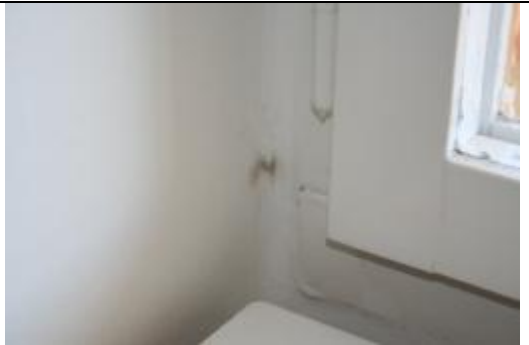
Figure 15a. Kitchen. Leak between window frame and arch.

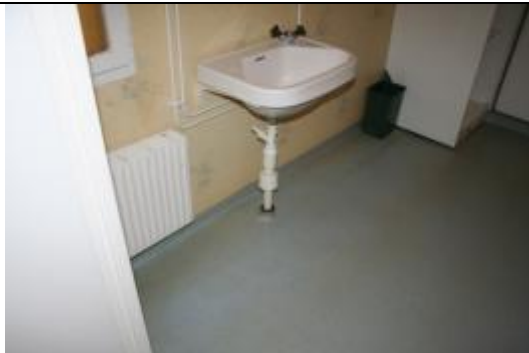
Figure 16a. Bath room. Leak through sewage pipe from washbasin and sewage pipe in joists. This is probably the reason for sewage smell in the bath room since water seal was full with water.

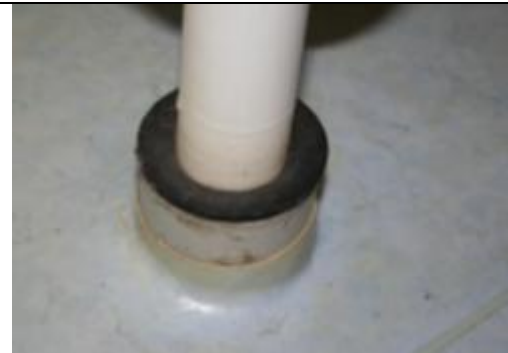
Figure 16b. Bath room. Leak through sewage pipe from washbasin and sewage pipe in joists. This is probably the reason for sewage smell in the bath room since water seal was full with water.

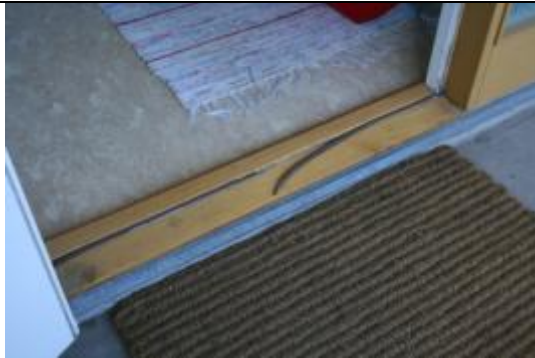
Figure 17. Front door. Leak through broken weather strip.

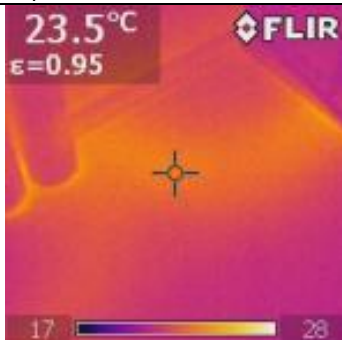
Figure 19a. Even though supply water temperatures is relatively low could surface temperatures of floor be measured to 23,5°C, due to heat losses from water pipes.
