**Pressure testing of the airtightness of buildings and sound level measurement with respect to the surroundings – sub-project under Technology procurement for heat recovery systems in existing apartment blocks.**

Bengt Bergqvist of Energianalys has carried out air permeability tests and sound measurements in apartment blocks for Åsa Wahlström of CIT Energy Management.

The air permeability tests were performed in accordance with Swedish Standard SS-EN 13829 during March and April 2010 in a total of 16 apartments in nine apartment blocks.

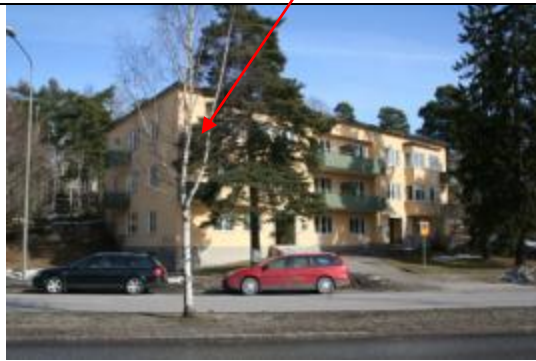
Figure 1. Spångavägen 74.

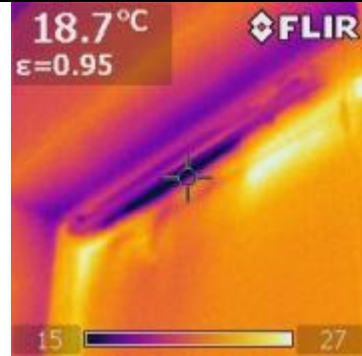
Figure 4b. External air device (type Biobe)

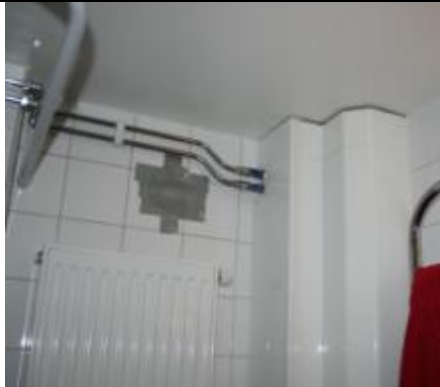
Figure 10a. The biggest leak was found at mounting for water pipes. Probably is fire tightening between pipe and structure untight and air may be overflow between apartments. The tenant has problem with smell of smoke from the neighbor.

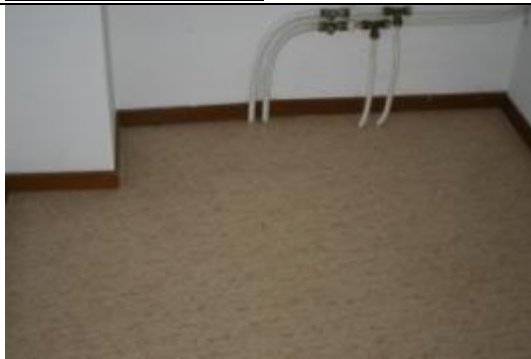
Figure 11a. Clothes cupboard.

Figure 11b. Heat losses from heat pipes to radiators.
